ACE-99-05

November 17, 1998

The purpose of this Special Airworthiness Information Bulletin (SAIB) is to advise registered owners of certain Cessna twin engine models of the need to determine if there is adequate alternate crankcase breather provisions.

This SAIB is being sent to registered owners of: Cessna 300 and 400 Series Model airplanes except for the 303, 336 and 337 series airplanes.

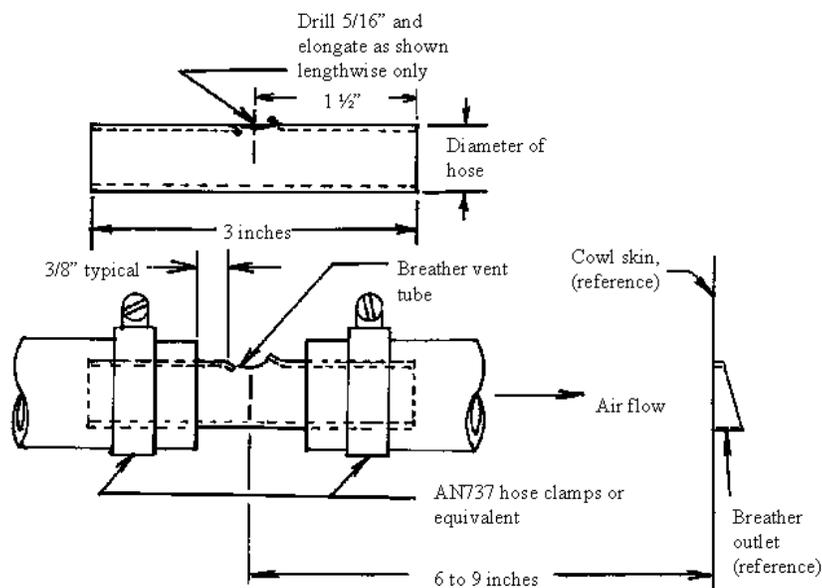
The Federal Aviation Administration (FAA) has received service difficulty reports concerning oil loss on certain Cessna twin engine airplanes. This oil loss was due to the forward crankcase oil seal being dislodged by abnormally high crankcase breather pressure. The abnormally high crankcase breather pressure was caused by icing of the crankcase breather vents. These airplanes either did not have, or had inadequate alternate crankcase venting provisions which are intended to ventilate the crankcase in the case of the icing of the primary vent. This condition may have occurred due to inadequacies in the original design or the unintentional deletion of the alternate venting provisions by field repair and/or modification. The original venting provisions were in many cases the installation of a hose section in the breather line that had a elongated hole in it.

venting provisions, which should be a slit or hole (at least approximately one inch by .25 inches) in the breather line within a minimum of six inches inside the cowling.

If these provisions do not exist, it is recommended that alternate crankcase venting provisions be incorporated per the below figure.
