SAIB: CE-10-20 R1

Date: May 12, 2010

SUBJ: Wing Structure; Wingtip Extensions

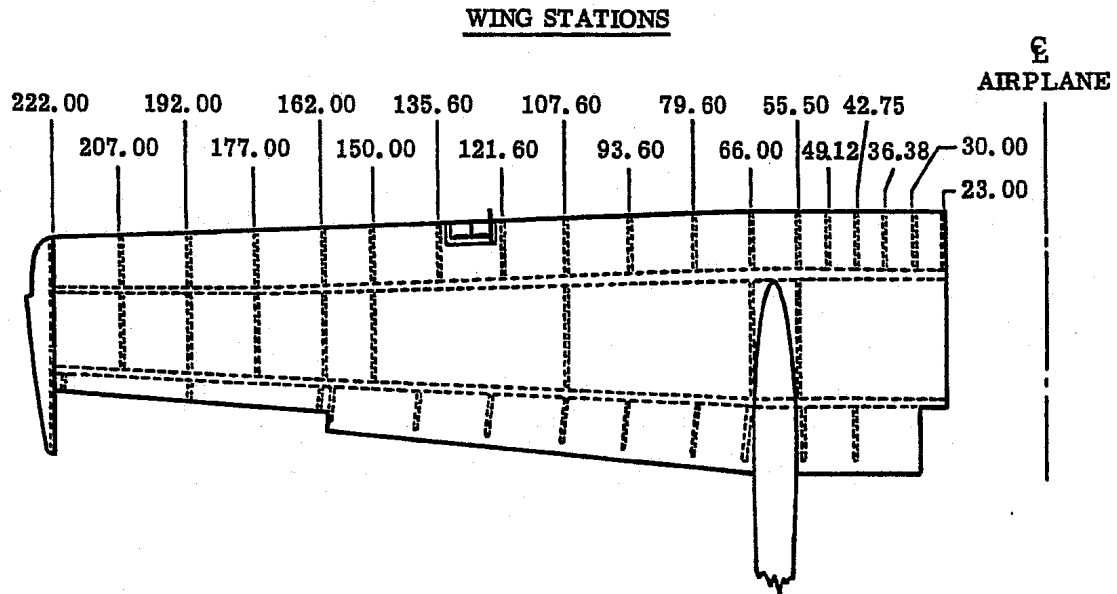
Focused inspection items to focus on:

- Wrinkles in upper wing skins;
- Cracking of the upper wing skins. Pay particular attention to any wrinkles, the radius between stiffeners at Wing Station (WSTA) 150 (under fuel tank covers), and unreinforced access holes;
- Smoking rivets at the rib near the inboard aileron hinge (WSTA 162);
- Missing fastener hardware, particularly for attachment of the tips;
- Excessive looseness of attachments of the tip extension to the wing and wing tip to wing extension when pushing up and down on the tip;
- Any signs of distress along both front and rear spars, particularly in the area around WSTA 177;
- Unusual repairs to the upper skins, particularly in the area of WSTA 150-162, and
- Inter-rivet buckling of the stringers attached to the upper surface skin, outboard of the fuel tank access covers.

1. Review and adhere to all published airspeed and maneuvering limitations for the modified airplane. Look for excessive "bowing" of the tip extensions in flight.
2. Perform a one-time general inspection of the wings for internal and external damage from Wing Station (WSTA) 23 to the wing tip within the next 100 hours time-in-service (TIS). Remove all wing access panels to conduct the inspection. Areas to focus on are listed below. Do this inspection following the appropriate manufacture's service information and any other appropriate guidance, such as FAA Advisory Circular AC 43.13-1B Acceptable Methods, Techniques, and Practices - Aircraft Inspection and Repair.
