SAIB: CE-10-21

SUBJ: Propellers/Propulsers; Propeller Overspeed in Piston Engine Aircraft

Date: March 17, 2010

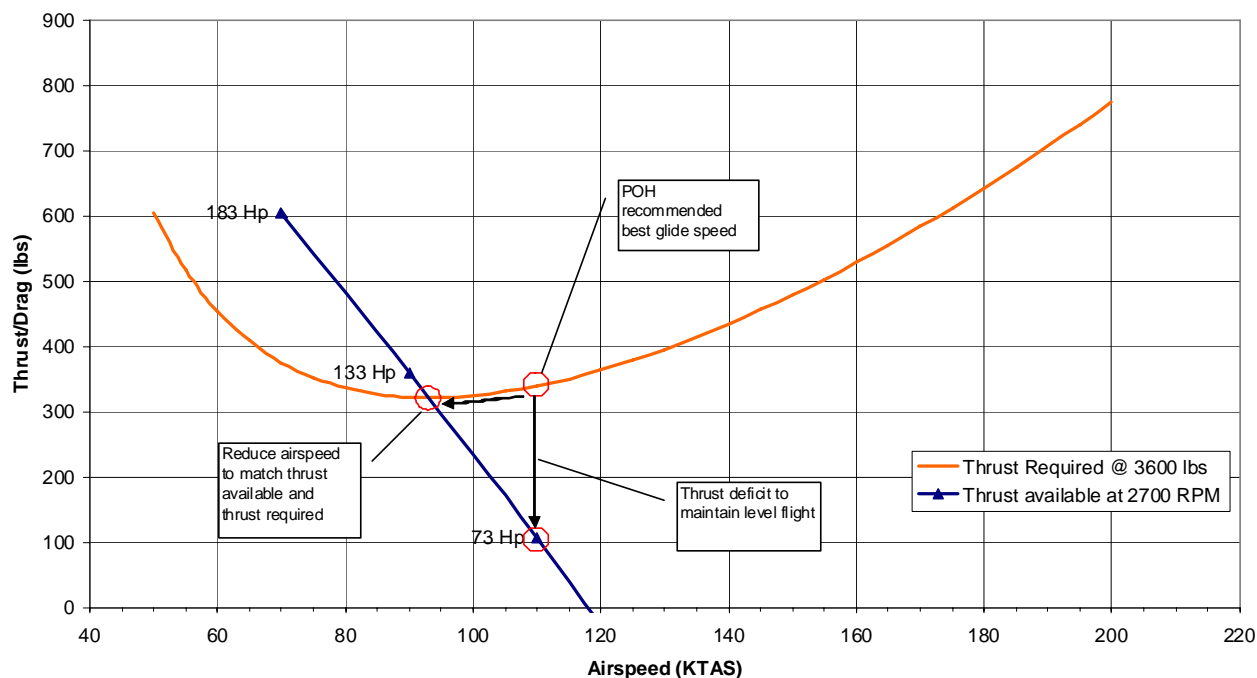
Example of Propeller Operation on Low Pitch Stop Estimated Thrust/Drag vs. Airspeed

It was determined that the propeller experienced a failure that caused the blade pitch change mechanism to move to the low pitch stop position. This caused the propeller to operate as a fixed pitch propeller such that it changes RPM with changes in power and airspeed. The low pitch setting allows for maximum power during take off but can result in a propeller overspeed at a higher airspeed.

The graph below shows thrust versus airspeed for a typical propeller model set at a 12-degree blade angle and maintaining 2,700 revolutions per minute (RPM). From the graph, note that at over 118 knots this propeller is incapable of generating a positive thrust and airspeed has to be lower than 95 knots to generate enough thrust to overcome the aircraft drag, i.e. maintain level flight. While different propeller models have different thrust characteristics and different aircraft have different drag characteristics, the concept remains the same – the lower the airspeed the more thrust there is available at a given RPM.

advise the pilot to control a propeller overspeed by throttle reduction and a reduction in airspeed as much as practical with an adequate margin above stall speed such that level flight can be maintained.

The operators of aircraft with variable pitch propellers should be aware that in certain instances of propeller overspeed, the airspeed necessary to maintain level flight may be different than the speed associated with engine-out best glide speed. The appropriate emergency procedures should be followed to mitigate the emergency situation in the event of a propeller overspeed; however, pilots should be aware that some reduction in airspeed may result in the ability for continued safe flight and landing. The determination of an airspeed that is more suitable than engine-out best glide speed should only be conducted at a safe altitude when the pilot has time to determine an alternative course of action other than landing immediately.
