SPECIAL AIRWORTHINESS INFORMATION BULLETIN

NE-04-73
August 3, 2004

CSB 665
 TECHNICAL PORTIONS
 FAA APPROVED

SUBJECT: MAGNETO CAPACITOR P/N 10-400615 INSPECTION AND REPLACEMENT.

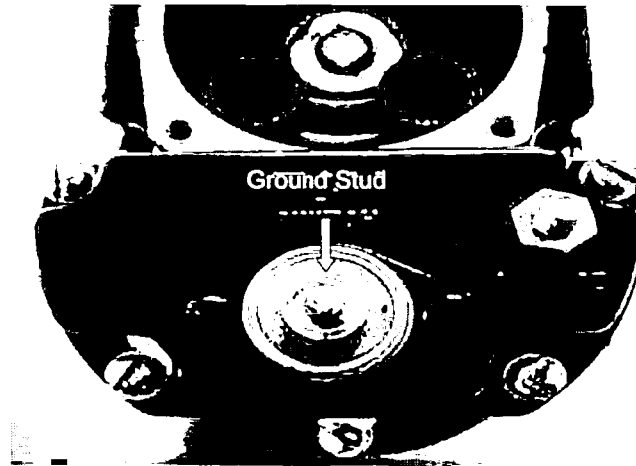
Figure 1

PURPOSE: TCM has identified a quantity of magneto capacitors part number 10-400615 which may have ground stud (also referred to as the P-Lead stud) threads that do not meet specification. This may allow the ground wire (P-Lead) to come loose, resulting in a hot magneto.

2. Remove the P-Lead from the capacitor ground stud. (Reference Figure 1)
3. Reinstall the P-Lead retaining nut and washer. Using a properly calibrated and certified torque wrench, torque the retaining nut to 27 inch-pounds.

4. If the P-Lead retaining nut can be torqued to 27 inch-pounds without slippage, no further action is required. Remove the retaining nut and reinstall the P-Lead. Torque the retaining nut to 15-17 inch-pounds. Make a log entry in the engine and airframe logbooks stating compliance with this bulletin.

5. If the retaining nut cannot be torqued to 27 inch-pounds, the capacitor must be replaced. Refer to section C or D of this bulletin, as applicable, for capacitor replacement procedures.

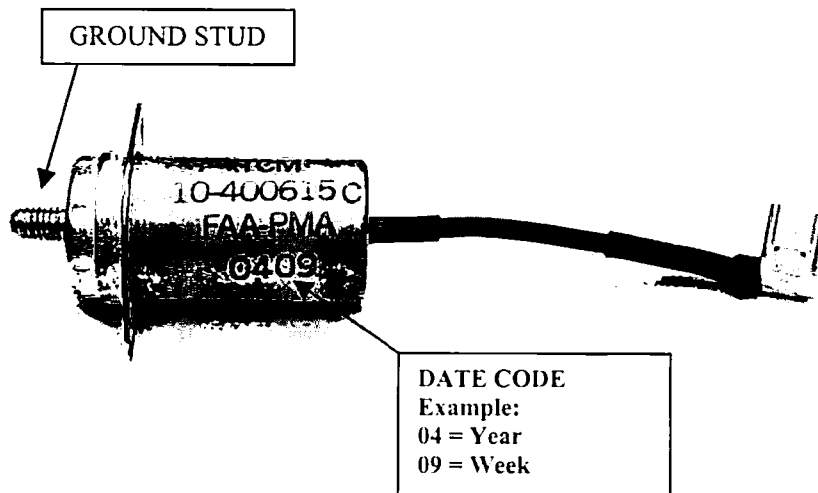
1. Examine each 10-400416 capacitor in spares stock for the stamped date code. (Reference Figure 2)
2. Dates codes of 03-44 through 04-17 must be removed from stock and returned to Teledyne Continental Motors under warranty through the TCM authorized distributor from which the affected capacitors were purchased.
3. Capacitors with date codes not listed above are not affected by this bulletin and cannot be returned for warranty consideration under this bulletin.
