# SPECIAL AIRWORTHINESS INFORMATION BULLETIN

NE-05-40  
March 18, 2005

DATE: February 21, 2005 Service Bulletin No. 565  
Engineering Aspects are  
FAA Approved

SUBJECT: Diaphragm-Type Fuel Pump Inspection/Replacement

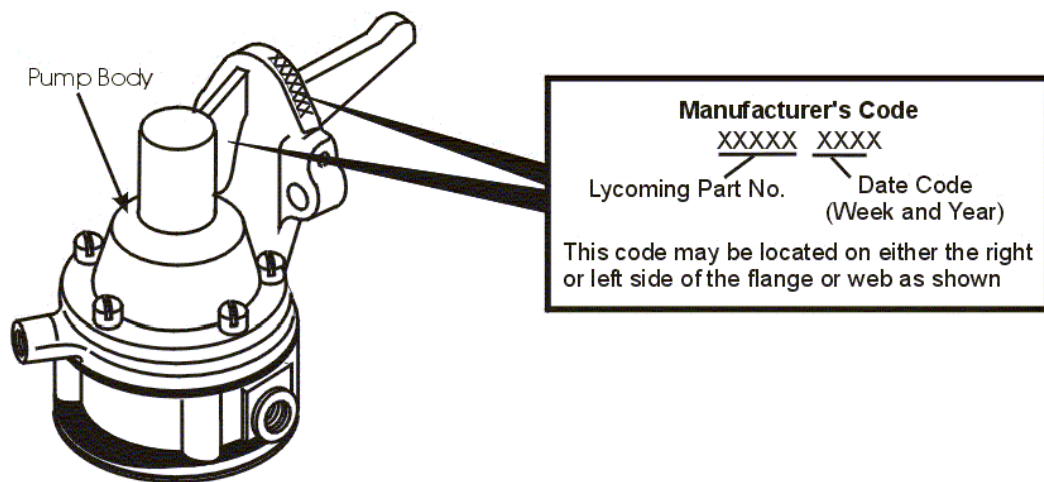
consists of the Lycoming P/N followed by the date code. Figure 1 of MSB 565 shows where the manufacturer's code can be found on the pump. The fuel pump may have to be removed in order to read the manufacturer's code on some aircraft.

To identify affected pumps, check the manufacturer's code scribed on the pump. (See Figure 1.) If the number is 154733201, the pump is affected and must be replaced prior to next flight.

Perform the inspection specified in Lycoming MSB No. 565 within 25 hours and replace the fuel pump prior to next flight if the date code is 3201.

**If your Lycoming engine has a diaphragm-type fuel pump with Lycoming P/N LW-15473 installed, and has a date code of 3201, the pump must be replaced prior to next flight.**
