SPECIAL AIRWORTHINESS INFORMATION BULLETIN

NE-05-89
September 30, 2005

This Special Airworthiness Information Bulletin (SAIB) **updates information we issued in SAIB NE-01-22, May 11, 2001.**

SUBJECT: Diaphragm-Type Fuel Pump Inspection/Replacement

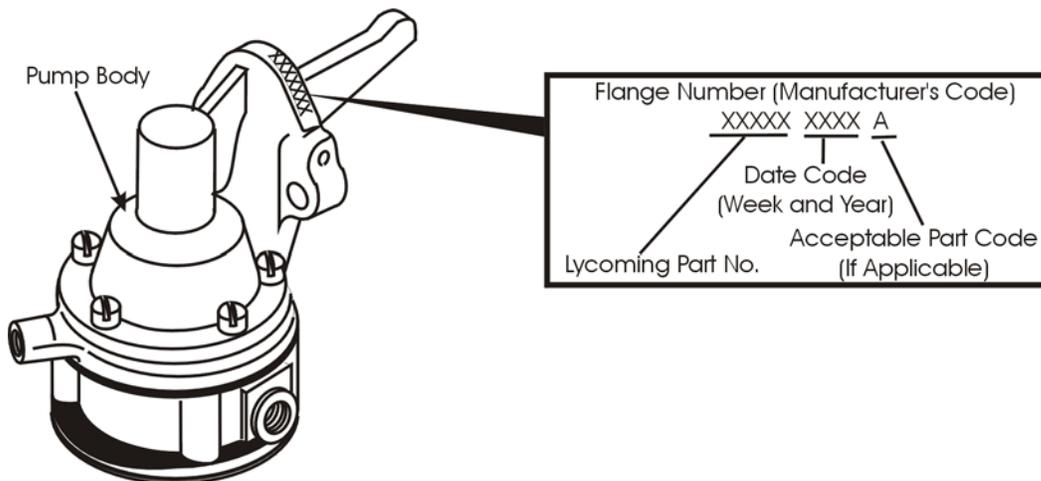
Figure 1

When an internal failure occurs, the check valve seat separates from its shaft due to an inadequate or improper assembly crimp. This allows the liberated parts to move within the housing and might cause a blockage of fuel flow. This failure may not be evident on the exterior of the pump, but might result in a decrease or loss of fuel flow and a corresponding decrease or loss of engine power.

- Textron Lycoming engine that has a diaphragm-type fuel pump, P/N LW-15399, LW-15472, LW-15473, or LW-16335 installed, with one of the following date codes in the 6th through 9th digit locations scribed on the pump:

0101	0201	0301	0700	0800	1100	1200
1300	1400	1500	1600	1800	2000	2100
2200	2300	2400	2800	2900	3000	3100
3200	3300	3400	3500	3600	3700	3800
3900	4000	4100	4200	4300	4400	4500
4600	4700	4800	4900	5000	5100	5200
0401

Example: 163354800 needs to be replaced as specified in Textron Lycoming Service Bulletin No. 548A.

- If the letter “A” is marked as a suffix to the date code, the *pump manufacturer has repaired the pump and replacement is not necessary.*

Example: 163354800A

To prevent a failure of Lycoming Engine fuel pump with P/N LW-15399, LW-15472, LW-15473, or LW-16335, we highly recommend you inspect your engines for the applicable fuel pumps, as shown in Figure 1, and replace the pumps as described in Textron Lycoming Service Bulletin (SB) No. 548A. We also recommend that you check your maintenance records for affected replacement fuel pumps **received after September 15, 2005** in the event that Lycoming's September 1, 2005 fuel pump recall didn't retrieve all affected pumps. Prior compliance with Lycoming SB No. 548 requires re-inspection of the fuel pump to ensure that a fuel pump from one of the date codes added by Revision "A" was not installed when originally complying with Lycoming SB No. 548.

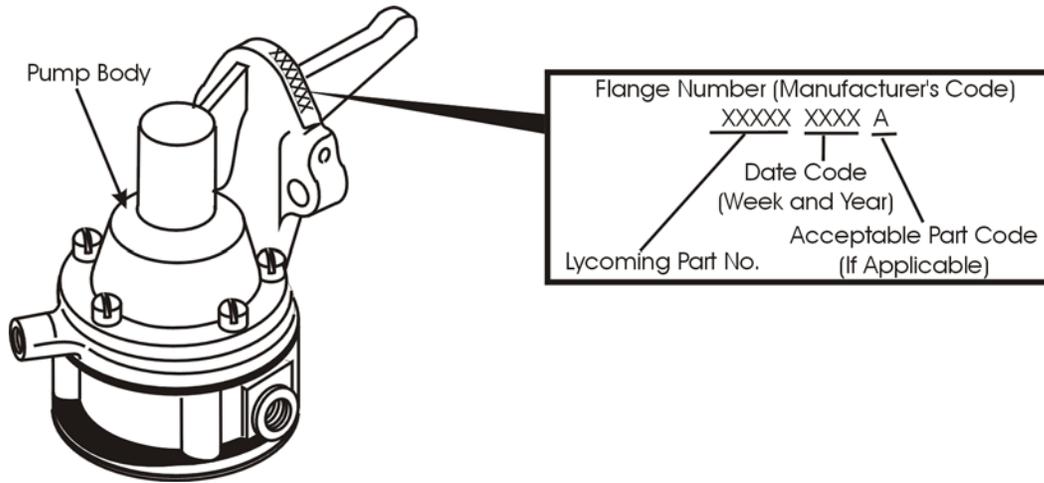
Figure 1

Lycoming has determined that a number of lots of diaphragm-type fuel pumps, Lycoming P/N LW-15399, LW-15472, LW-15473, and LW-16335, may not have been manufactured in conformance with acceptable standards. In the event operation of the pump is compromised, restricted fuel flow or loss of fuel pressure could result.

To identify affected pumps, check the manufacturer's code scribed on the flange of the pump (See Figure 1). If the first five digits are 15399, 15472, 15473, or 16335, and the 6th through 9th digits are 0700, 0800, 1100, 1200, 1300, 1400, 1500, 1600, 1800, 2000, 2100, 2200, 2300, 2400, 2800, 2900, 3000, 3100, 3200, 3300, 3400, 3500, 3600, 3700, 3800, 3900, 4000, 4100, 4200, 4300, 4400, 4500, 4600, 4700, 4800, 4900, 5000, 5100, 5200, 0101, 0201, 0301 or 0401, the pump is affected and must be replaced.

If the letter "A" is marked as a suffix to the date code, the pump has been brought into conformity and need not be replaced.

If your Lycoming engine has a diaphragm-type fuel pump with Lycoming P/N LW-15399, LW-15472, LW-15473, or LW-16335 installed, and has a date code of 0700 through 0401, the pump must be replaced within the next 100 hours of operation or 180 calendar days from the date of this Service Bulletin, whichever occurs first.
