<b>MAJOR REPAIR AND ALTERATION</b> <b>(Airframe, Powerplant, Propeller, or Appliance)</b>					Form Approved OMB No. 2120-0020 228/2011	Electronic Tracking Number  For FAA Use Only
<b>INSTRUCTIONS:</b> Print or type all entries. See Title 14 CFR §43.9, Part 43 Appendix B, and AC 43.9-1 (or subsequent revision thereof) for instructions and disposition of this form. This report is required by law (49 U.S.C. §44701). Failure to report can result in a civil penalty for each such violation. (49 U.S.C. §46301(a))						
<b>1. Aircraft</b>	Nationality and Registration Mark <b>USA N8129G</b>			Serial No. <b>21059429</b>		
	Make <b>Cessna</b>			Model <b>T210</b>		Series <b>K</b>
	Name (As shown on registration certificate) <b>JOHNSON RICHARD A TRUSTEE</b>			Address (As shown on registration certificate) Address <b>4923 S Meadows PL</b> City <b>Chandler</b> State <b>AZ</b> Zip <b>85248</b> Country <b>US</b>

USA N8129G

Description of Major Repair: Compliance with TEXTRON SEL-57-06 WINGS - MODEL 210 CARRY-THRU SPAR ONE-TIME EDDY CURRENT INSPECTION. Work performed by Roark Summerford (A&P 3631954) and Richard Johnson (A&P 3402889) in accordance with SEL-57-06.

## Structural Substantiation of S

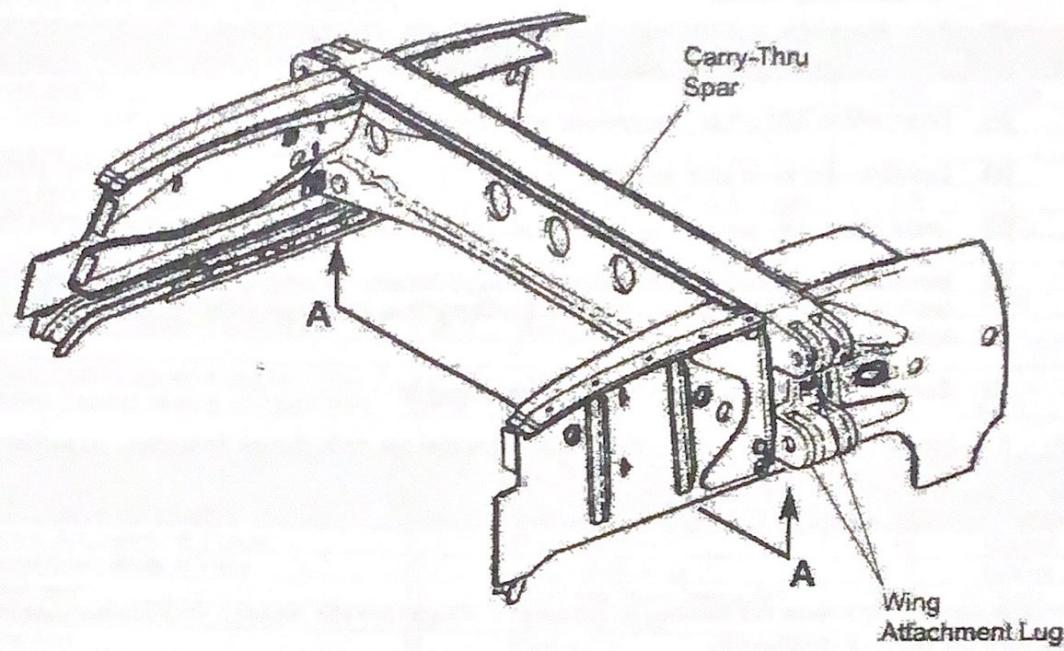
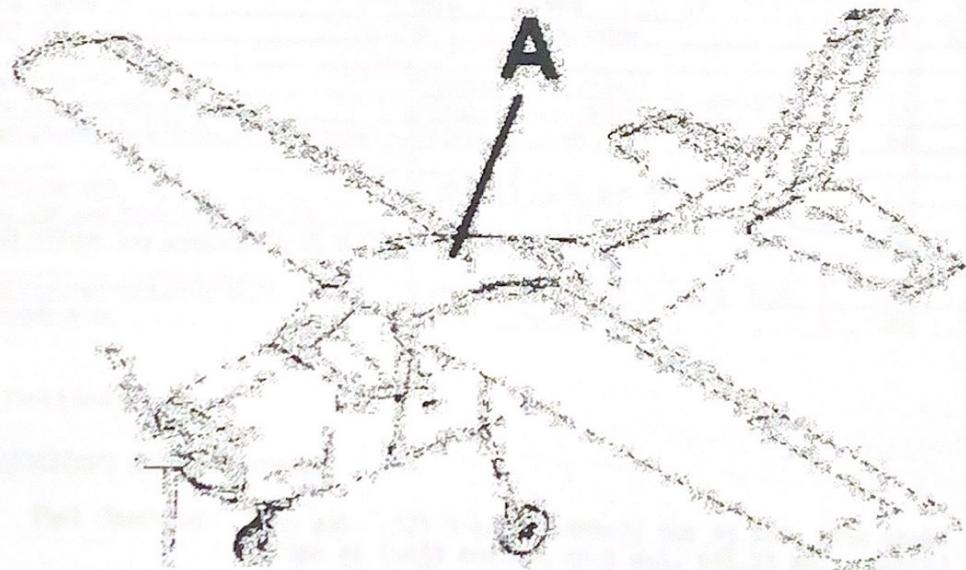
3.1 Installation Location

3. Situation for Analysis:  
Cessna 210 Spar inspection repair.

- A. If corrosion is found on the carry-thru spar, the area can be reworked as follows:
  - (1) Use 180 grit or finer aluminum oxide abrasive paper, cloth or pads to carefully remove corrosion and blend that area locally around the affected region.

- (2) Make sure to only remove the minimum material necessary to blend the corroded surface with the surrounding surface.
  - (3) Maintain a minimum of 20:1 blend to depth ratio.

- (4) Leave no sharp edges after blending.
  - (5) Finish with a 220 grit or finer grained aluminum oxide sandpaper.
  - (6) Use clean dry air to blow off dust.

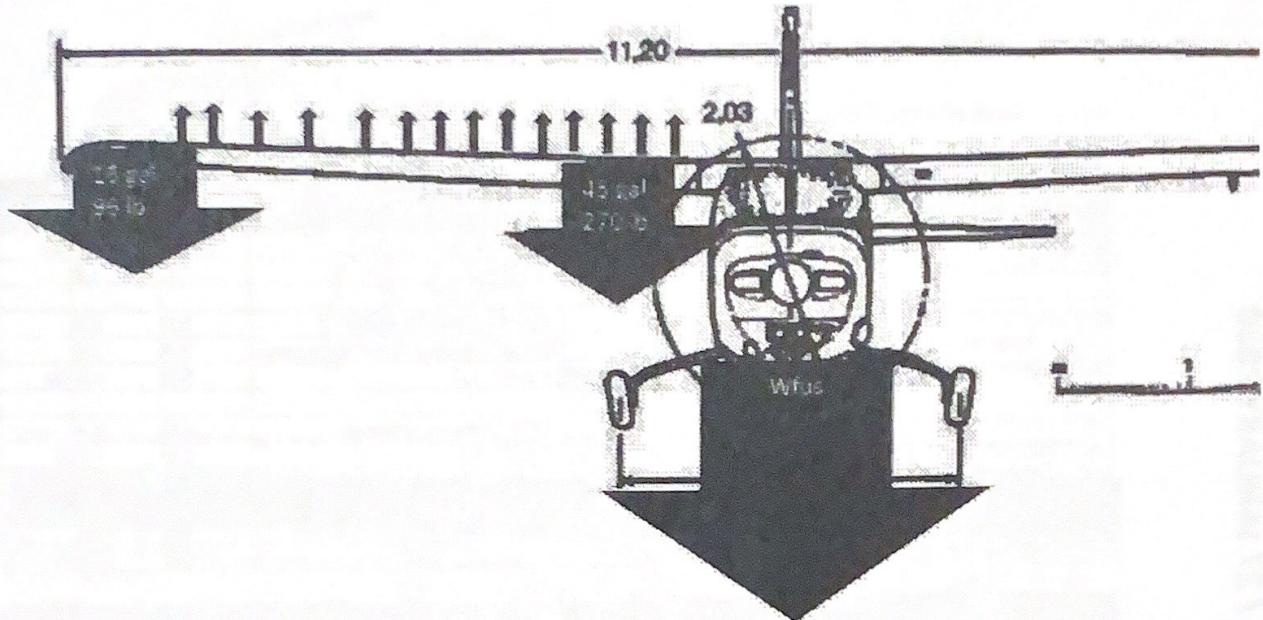
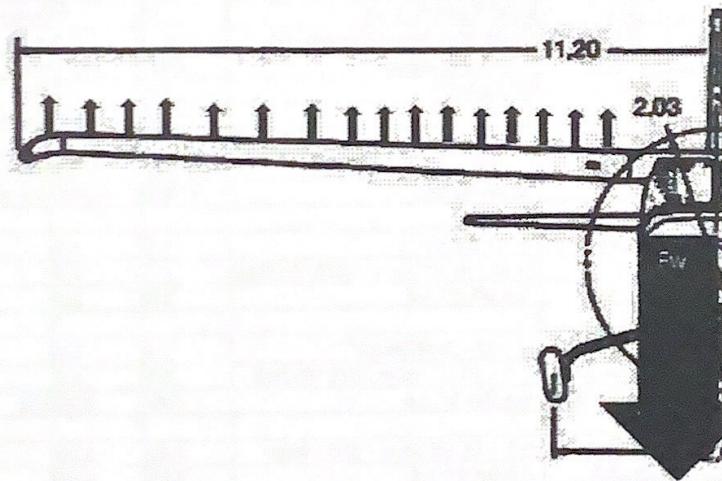
Tip Tank Loading:

Location/Value	Equation				
Acceleration	G	CAR3.188 Gust Load Factor	5.56	7.20	G
Downward Force on wings	$F_{\text{down}} = W_{\text{fus}} * G$		13841	8131	lbs
Max single wing load	$F_{\text{wing}} = (W_{\text{f}}/2) * G$		6920.7	4065.5	lbs
Distributed Load on single wing	$w = P_{\text{wing}} / L_{\text{wing}}$		35.310	20.742	lbs/in
Max single wing moment on Spar	$M_{\text{wing}} = w * L^2 / 2$		678,231	398,417	in lbs

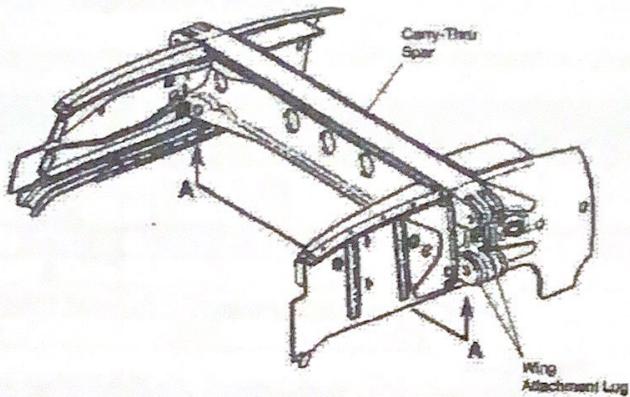
Spar Lugs translate wing bending into tensile load on the spar flange

Spar Clevis Bolt Arm	Base		6	6	in
Pitch Moment	PM	RC = PM / Base	678,231	398,417	in-lbs
Reaction tensile force on Spar Flange	RF	= PM / Base	113,038	66,403	lbs

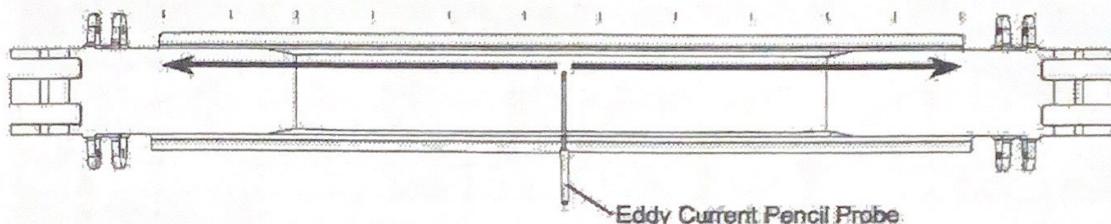
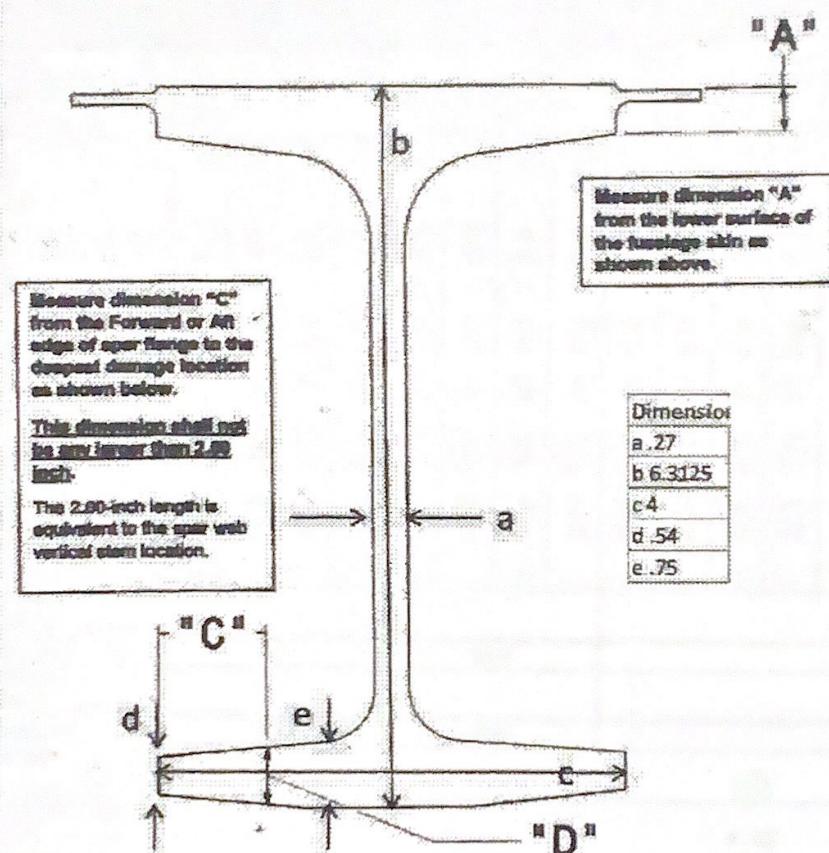
VIEW A-A

View Looking Up at Lower Surface of the Carry-Thru

"A" - Vertical thickness of end of upper spar flange.

Measure dimension "A" from the lower surface of the skin as shown above.

"C" - Horizontal distance from end of spar flange to deepest spot of corroded area being evaluated.

"D" - Vertical thickness of spar flange at deepest spot of corrosion.
