TECH NOTE

No. 001

CessnaPilots Association™

Nose Wheel Shimmy

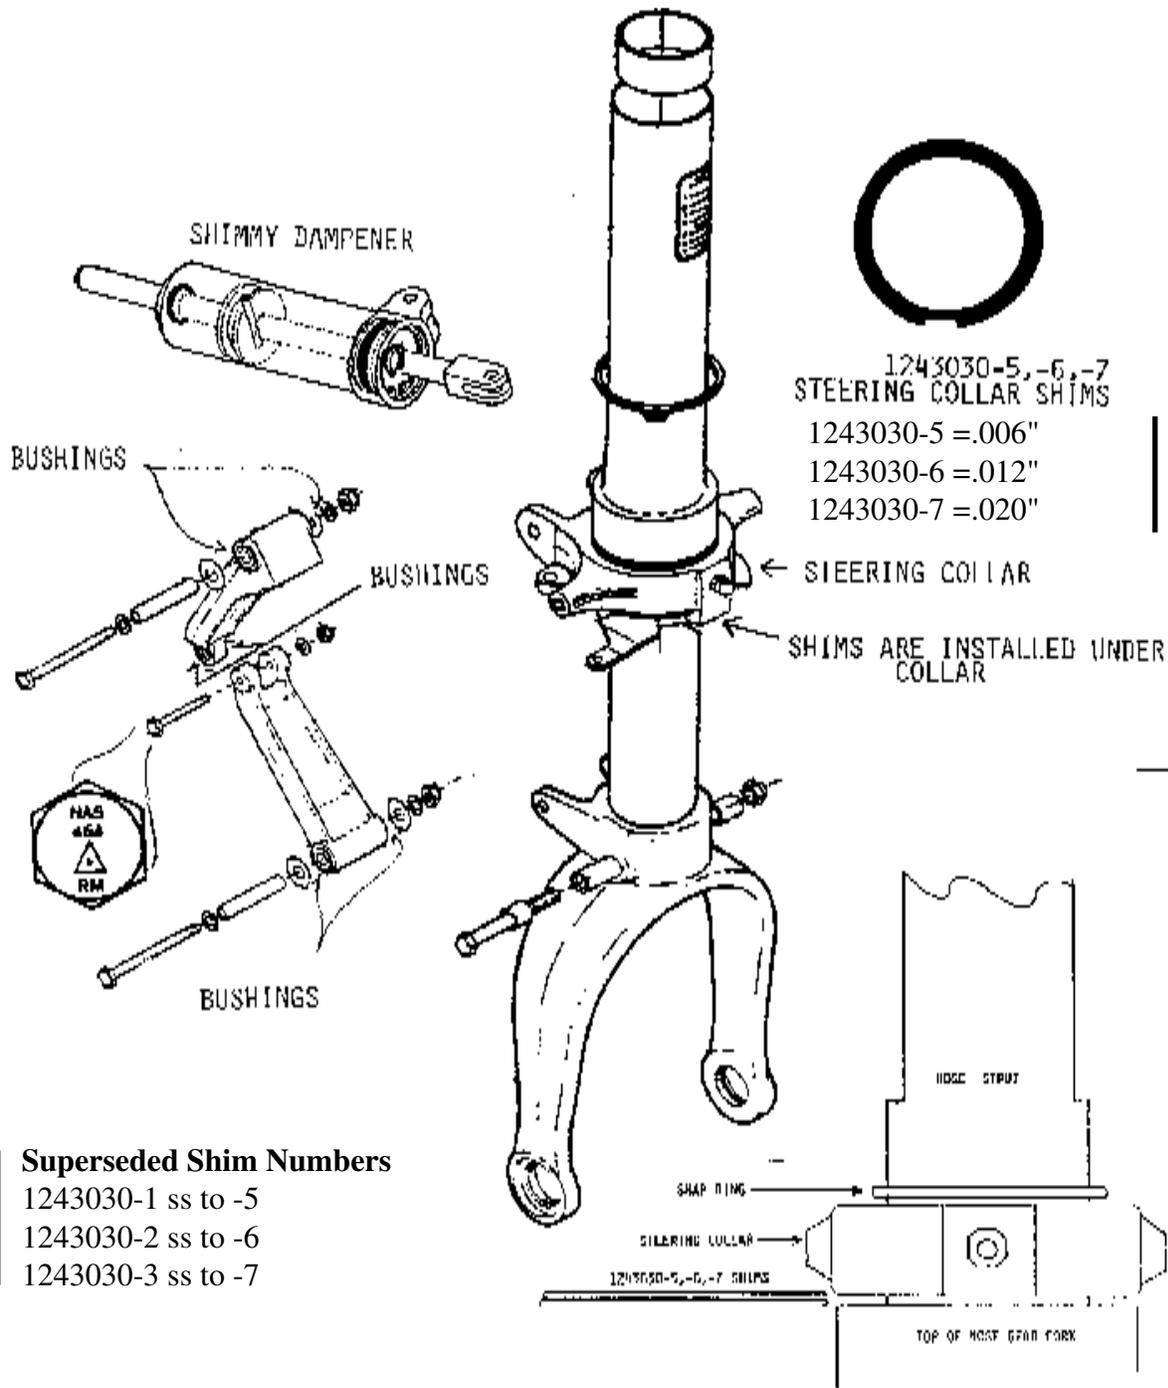
Superseded Shim Numbers

- 1243030-1 ss to -5
- 1243030-2 ss to -6
- 1243030-3 ss to -7
