# TECH NOTE

No. 003

CessnaPilots Association™

## Uneven Fuel Feeding in Single Engine Cessnas

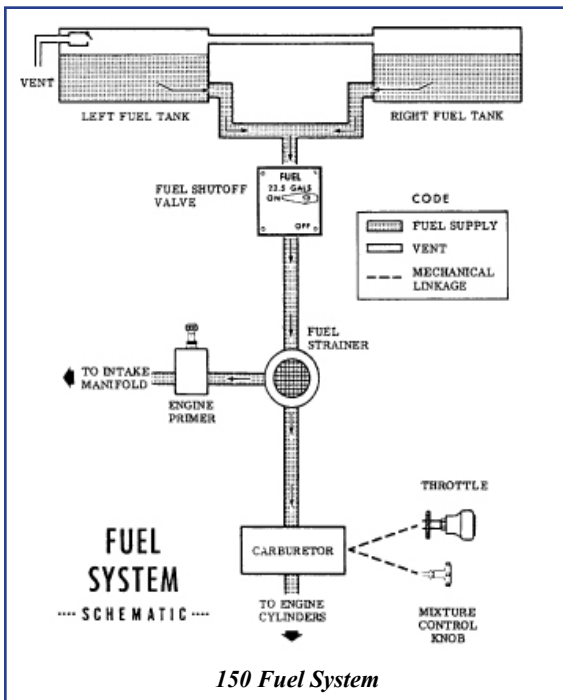
The air pressure in the tanks will also be a force acting to push fuel down the fuel feed lines. Ideally in the Cessna single engine aircraft this pressure will be slightly above ambient, that is the pressure of the outside air. This air pressure in the tank is often referred to as 'head pressure', meaning the pressure above the fuel level that is pushing the fuel down the fuel feed lines. The actual head pressure is important, a slight amount of pressure is necessary to hold fuel bladders in place and too much pressure can push fuel around and cause uneven fuel feeding. Also very important is the relationship of the head pressure to ambient air pressure. In regards to even fuel feeding, the head pressure in both tanks must be equal for the tanks to flow at the same rate. If the tanks do not

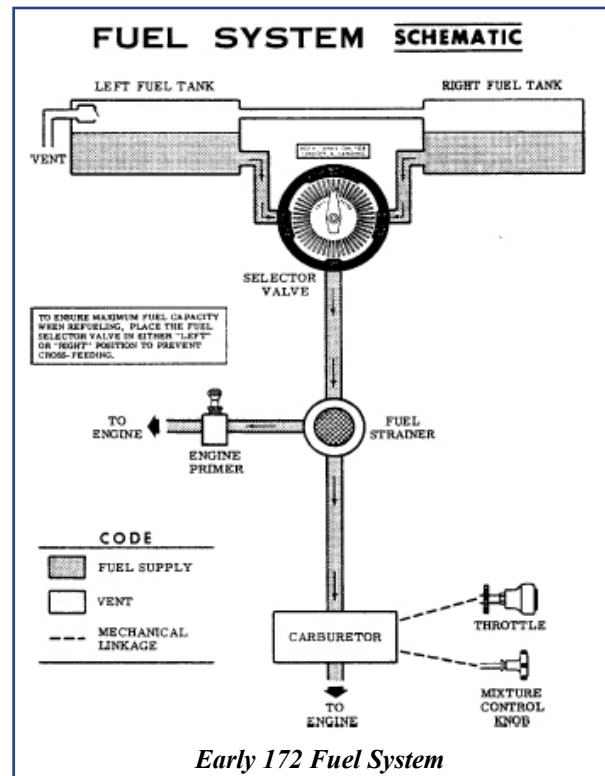
To understand what causes uneven fuel feeding we have to go through some of the basics of the fuel system. First we need to know that in most of the single engine Cessnas with carbureted engines two forces cause the fuel to move from the fuel tank to

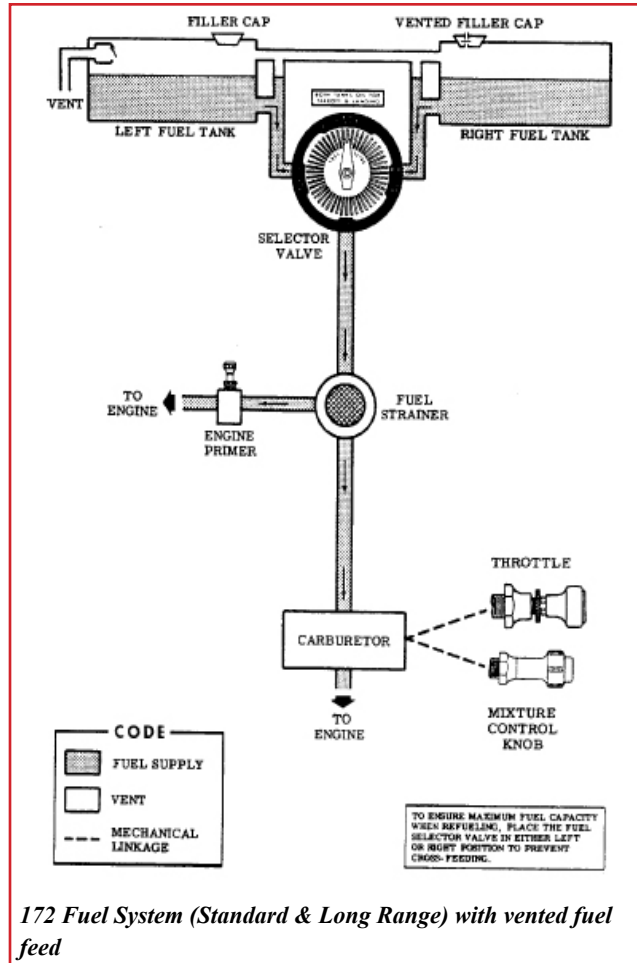
What the engineers hadn't given proper consideration to was wing dihedral and fuel slosh. Cessna wing tanks can be very long and shallow, on the 182 Skylane the long range tank is only 8" deep but is 7 feet long! This shallow, wide shape makes the fuel feed very sensitive to tank, or head, pressure. Wing dihedral places the outboard portion of the fuel tank above the inboard portion, sometimes by as much as several inches. This means that when the tanks are full the vent interconnect line is below the fuel level and is full of fuel. When air enters the left tank from the vent line to replace fuel being used, the pressure pushes fuel from the left tank through the vent interconnect into the right tank, replacing any fuel that has been used from the right tank. In this manner the right tank can remain full even while fuel is being used from it while the left tank goes down even faster than fuel is being fed

to the engine from it! This transferring of fuel from the left tank to the right tank will continue until the fuel level in the left tank drops below the height of the vent interconnect line. In fact the fuel transfer can continue for awhile even after the fuel level in the left tank has dropped below height of the vent interconnect line because motion in flight will tend to slosh some fuel into the vent interconnect line from time to time and this fuel will be pushed/pulled into the right tank. It is only when the fuel level in the left tank is so low, usually around half tank level, that none of the remaining fuel in the left tank can make it's way to the vent interconnect line that the fuel passage from the left tank to

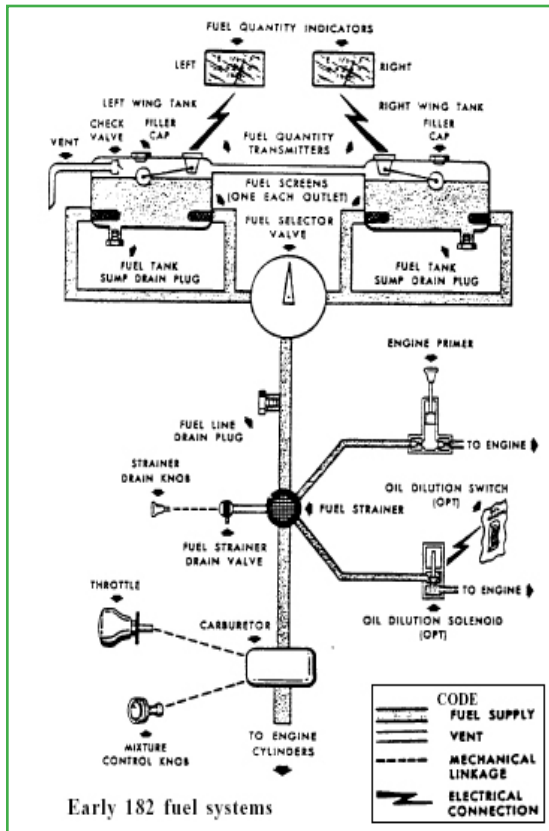
Early 182 fuel systems

Cessna, hearing complaints from owners on uneven fuel feeding, tried several things to improve the situation. With the 182 with long range tanks they extended the vent interconnect lines inside the tanks along the top to the outboard edge of the tanks. This began with long range tanks installed in the 1964 182G, s/n 18255059. The idea was that this would raise the vent interconnect line above the fuel level in all cases except with absolutely full tanks. This idea might

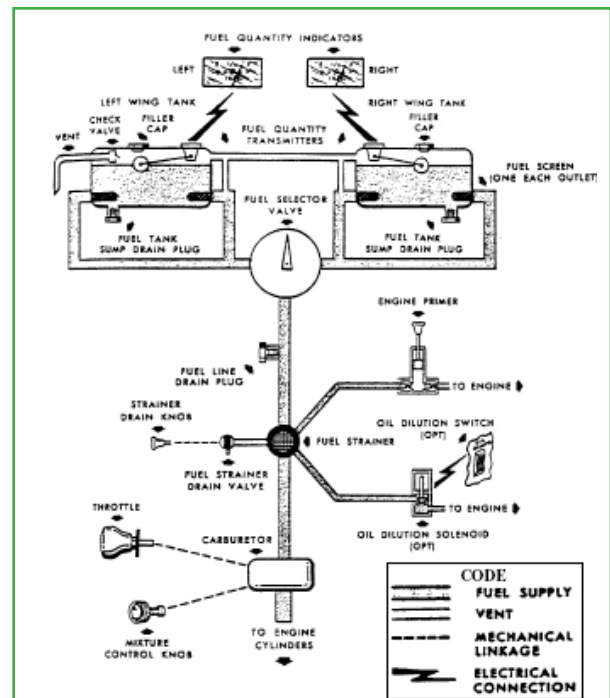
*NOTE: The fuel system shown in this schematic is applicable to the Model 182, beginning with serial # 18255786, as well prior serials on which Service Kit No. SK182-38 (thru serial # 18255785) or SK182-41 (thru serial # 18256144)*

182 fuel system with vented fuel feed lines

have worked fairly well except that about the same time, beginning with s/n 18255786 and on, the engineers made another change to the 182's fuel system. Having suspicions that the problem was related to unequal pressures in the tanks, they made an attempt to equalize pressure throughout the system as much as possible by venting the forward

fuel feed lines to the vent interconnect line running across the top of the fuselage. What this actually does is permit fuel to move from one tank to the other any time there is different head pressure in the tanks, even if the fuel level in the tank is below the height of the vent interconnect line. What will happen is that the tank with the higher head pressure will push fuel through the forward fuel feed line up to the vent interconnect line, across the top of the cabin and down into the vent line for the forward fuel feed line of the other tank (See Drawing). There can be a number of causes of this uneven head pressure which will be discussed a little further on.

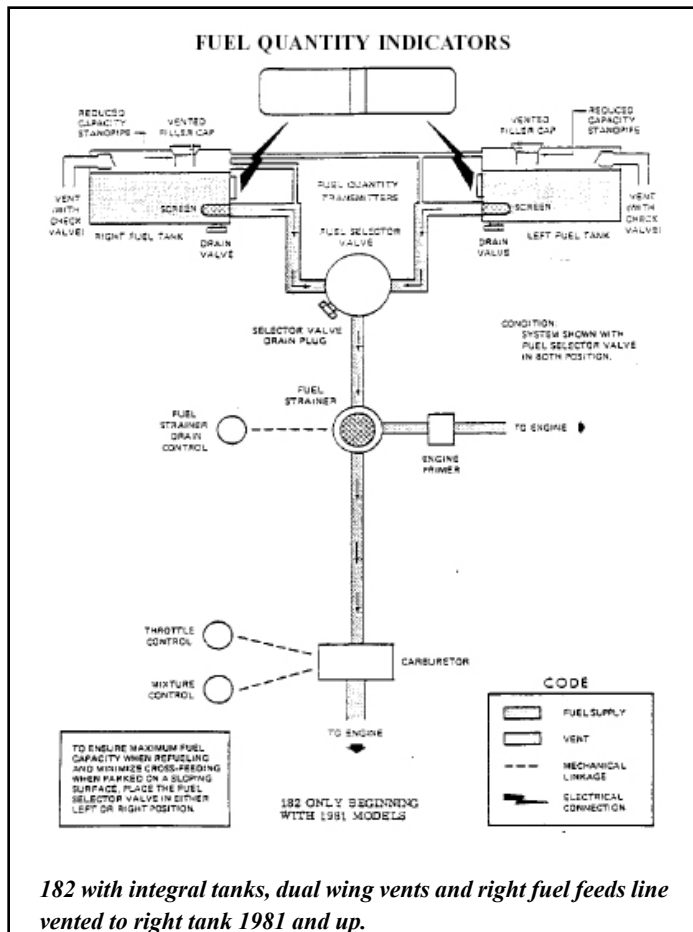
182 with integral tanks, dual wing vents and right fuel feeds line vented to right tank 1981 and up.

Again with the 182 series aircraft Cessna made another change. Beginning in 1981 with serial number 18267716 Cessna rerouted the vent line for the forward fuel feed line on the left tank. No longer did it connect with the vent in-

terconnect line, rather the forward fuel feed line was vented by a line that came from high in the left tank itself. By isolating one of the forward fuel feed lines from the vent interconnect line the passing of fuel from one tank to the other when the fuel level was below the vent interconnect line was stopped. The service manual describes vent position adjustment procedures for evening out fuel flows.

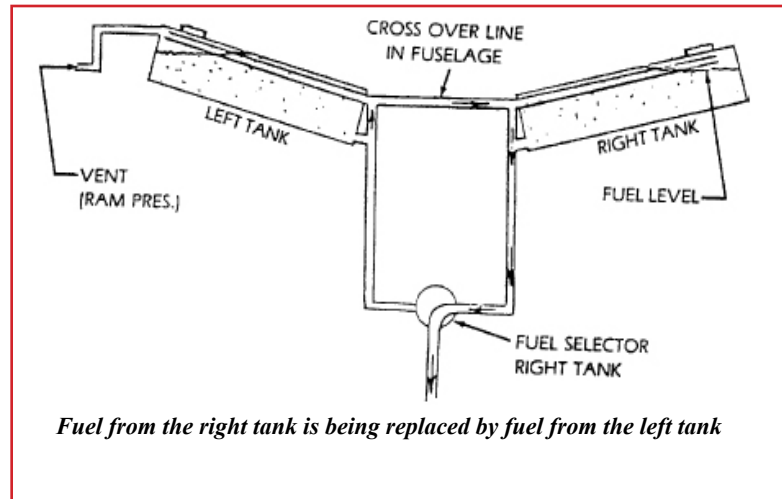
*Fuel from the right tank is being replaced by fuel from the left tank*

One good thing to note, and it is an important one, is that this is not really a problem of uneven fuel quantities being fed to the engine. Actually the engine is receiving approximately the same amount of fuel from each tank at any given time with the fuel selector in the 'BOTH' position. It appears to be uneven fuel feeding on the gauges because the fuel being used from the right tank is being replaced by fuel
